Soils and earthworms as a final chapter in the narrative of a steelworks

Butt, Kevin Richard and Quigg, Siobhan Marie

Butt, Kevin Richard ORCID: 0000-0003-0886-7795 and Quigg, Siobhan Marie (2020) Soils and earthworms as a final chapter in the narrative of a steelworks. The Glasgow Naturalist, 27 (2).

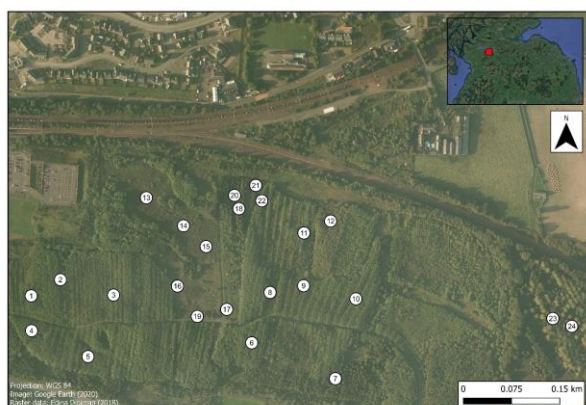
Fig. 3. Aerial view of the 35 ha reclaimed Hallside site, with position of the 2018 sampling sites indicated: 1-12, willow (*Salix* spp.); 13-17, grassland; 18-19, birch (*Betula* sp.); 20, Norway spruce (*Picea abies*); 21, Scots Pine (*Pinus sylvestris*); 22, cherry (*Prunus* sp.); 23-24, aspen (*Populus tremula*). Inset shows position of site in lowland Scotland (EDINA Digimap Service / Google Earth 2020).

During spring 2018, investigations were undertaken within the reclaimed areas from the 1990s, with comparisons drawn from sampling in adjacent areas that were unadulterated. Fig. 3 shows an aerial view of the site and the 24 selected sampling points. Most of these were in the dominant vegetation (willow) but other tree-covered areas were also targeted along with more open grassland.

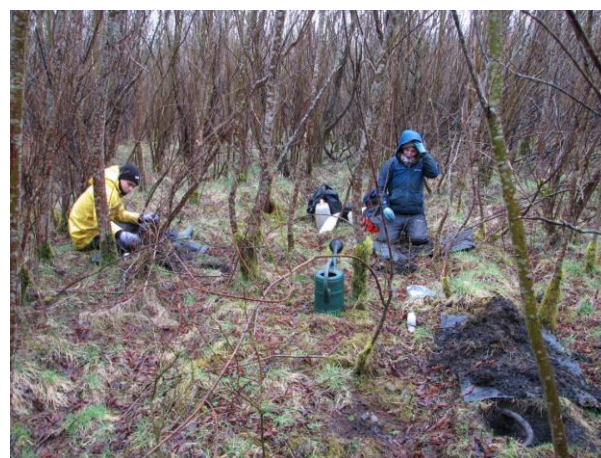
Fig. 4. Sampling for soil and for earthworms among willow at Hallside in 2018. (Photo: K.R. Butt)

The earthworms on site were sampled by digging a 0.1 m² soil pit to 25 cm and hand-sorting the soil extracted on plastic sheeting in the field (N = 3 per location). In addition, to extract deep burrowing earthworms, an expellant of mustard powder and water (5 g l⁻¹) was applied to the base of the soil pit (Butt & Grigoropoulou, 2010) (see Fig. 4). Earthworms were preserved in 4% formaldehyde for identification using the nomenclature of Sherlock (2018). In the laboratory, preserved masses were determined individually for species from each site and assigned to Bouché's (1972) ecological categories (epige, endoge or anecic). Statistical methods (ANOVA) were applied, as appropriate, to determine if the vegetation cover had an effect on the earthworm community density or biomass (per unit area). Willow sampling points were subdivided into either standard and "wet", based on observed standing water and tree height. In addition, Shannon-Wiener diversity index calculations were made, and comparisons drawn with previous (2000 and 2005) monitoring results from the site.

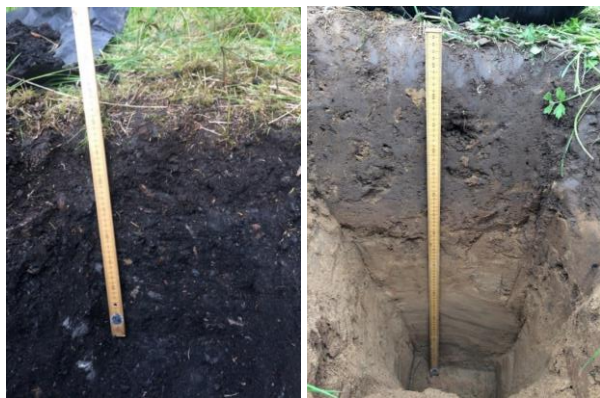
Fig. 5. Soil pits at Hallside. Left: in reclaimed soils below grassland (only possible to 45 cm due to stones and compaction). Right: in unadulterated sandy soil below aspen (to 1 m). (Photo: K.R. Butt)

Soils in the reclaimed areas proved very difficult to dig as they had a high stone content. No pits could be dug further than a depth of 0.45 m and many digging attempts were hampered by large rocks. Fig. 5 shows that above the dark compacted, stone-laden horizon, there was a lighter less stony, organic A-horizon of some 0.15 cm from the soil surface. In control soils away from the reclamation site, major differences were observed (Fig. 5). Here, digging to 1 m was possible, with the upper (0-35 cm) organic layer determined as a grey, sandy clay loam above 35-100 cm of yellow sand. The upper layer held small fragments of colliery spoil as the area had previously been agricultural land and had been ploughed prior to alder planting.
